Serious Injury

- **Incident date:** 28/02/2019
- **Event:** Structural collapse
- **Location:** MOOREBANK

Incident Overview

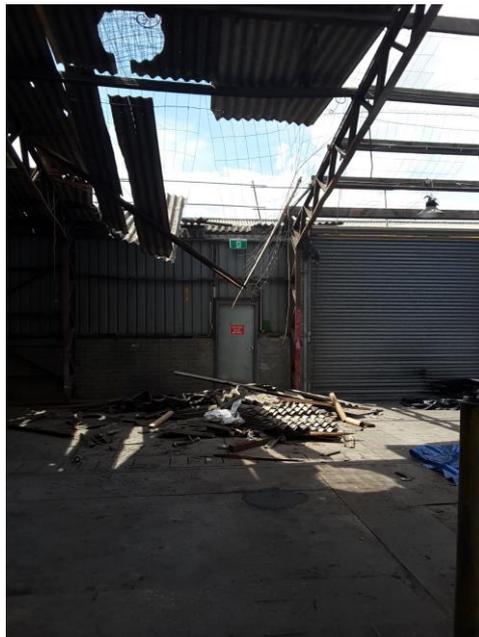
Eight workers were removing an asbestos roof and stacking the asbestos sheets on the existing roof. The condition of the timber roof structure was unable to support the weight of the stacked sheets. Part of the roof collapsed and two workers fell with the asbestos sheets to the concrete floor below. The fall was approximately four metres. The workers were not wearing any safety harnesses at the time of the incident, however, there was temporary roof edge protection and roof safety mesh in place.

Photograph 1: Construction site where works were being done.

When working on existing structures, such as during refurbishment, renovation or demolition work, a competent person should assess the integrity of the structure and determine whether it is strong enough to support the weight of workers and materials, and, will remain stable during the work. Additional propping or bracing may be required, and roofing material may need to be lowered as they are removed rather than stacked on the roof.
