## Fatality

- **Incident date:** 23/05/2019
- **Event:** Crush injuries while working on tipper truck
- **Location:** Moree

### Incident overview

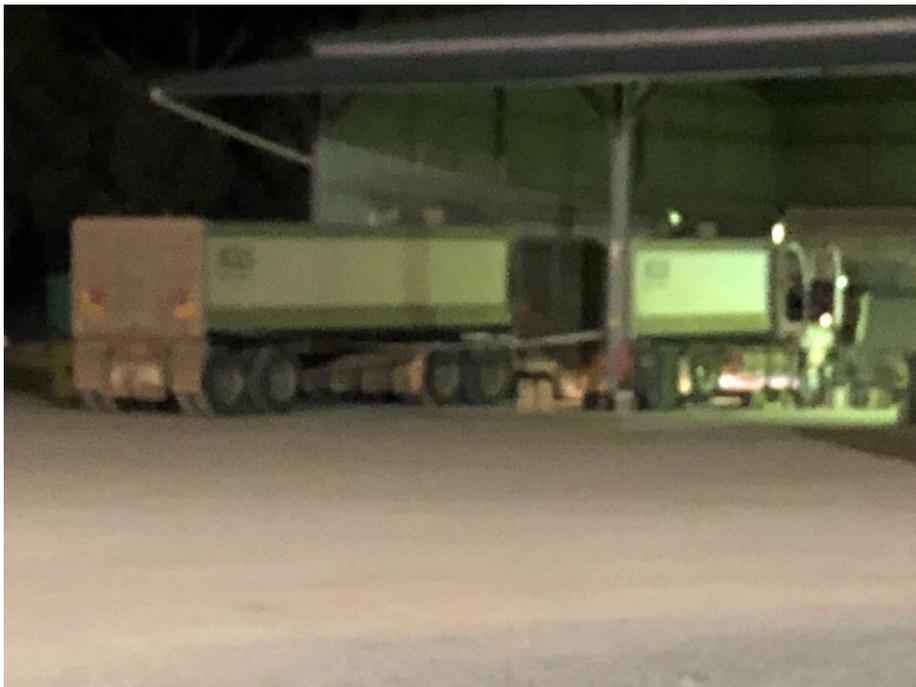
A worker was greasing a tipper truck after undertaking deliveries. The worker had raised the tipper body on the truck and was leaning over the passenger -side between the chassis rail and the tipper body. The tray descended and the worker sustained fatal crush injuries.

Image: The heavy vehicle the worker was working on.

Businesses must consider 'reasonably practicable' control measures to manage the risks when carrying out inspections or doing maintenance/repair work underneath raised tipping or tilting trays on trucks or trailers.

- safe systems of work are developed and implemented before starting work to minimise the risk of working under a tipper tray
- maintenance activities are carried out by a competent person in accordance with the manufacturer's recommendations

- work or inspections are not undertaken between a raised tipper tray and the vehicle chassis rails, unless the tray is supported by a mechanical stop, such as a safety bar correctly applied, or suitably designed props or stands

- wood is never used to support an elevated tipper tray
- limiter cables are protected from inadvertent activation by the use of shrouds or guarding
- controls for raising and lowering the tipper tray are clearly marked and protected from inadvertent operation, and the system is isolated (eg truck is turned off and keys removed from ignition)

- hydraulics and mechanical parts are regularly inspected and maintained by a competent person
- worn or damaged parts are repaired or replaced
- new vehicles have safeguards fitted to the tipper tray system, such as built-in props/stops to secure the tray when elevated.
