Incident Information Release

SAFEWORK NSW

Fall through plastic skylight panel

6 December 2019

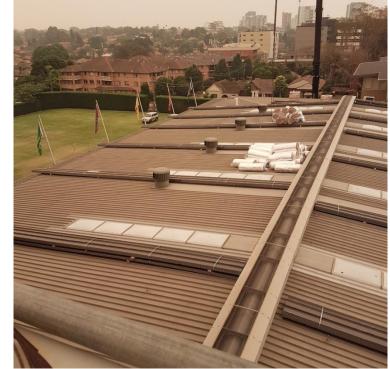
Incident Location

A 31-year-old man suffered critical injuries when he fell more than 10 meters through a plastic roof-panel at a school in Croydon.
