Incident Information Release

ISAFEWORK NSW

Serious Injury

Incident date: 13/09/2018
Event: Hit by falling object
Location: Seven Hills

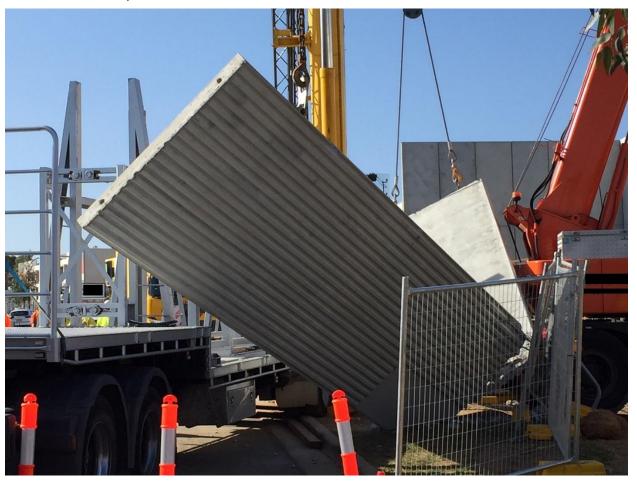
A 10 tonne prefabricated concrete panel approximately 12m in length and 2.1m in width was being lifted off a truck using a crane and was to be rotated mid-air and moved into position as part of constructing a commercial premises. However, as it was being lifted it broke into pieces, striking and injuring a 50 year old worker assisting with the lift.

View of the pre-cast concrete panel which broke into pieces when being raised into place.

Tilt-up and pre-cast panels must be designed for both erection loads and for loadings experienced when they make up part of the completed building or structure (i.e. 'in-service loads'). The loads applied to the panel during lifting off the casting bed, transport, handling, erection, and while the panels are temporarily braced are different from loads applied when part of the final structure. The erection designer(s) must therefore design the panel for all types of loading. Erection crews must then ensure panels are lifted and braced in the manner specified by the erection designer(s).

Tilt-up panels should only be lifted when the concrete has cured long enough to attain the minimum required concrete strength specified by the lifting insert supplier. The minimum concrete strength for most proprietary brand lifting inserts is 25 MPa. Some inserts may require a higher strength than 25 MPa.
