Serious Injury

- **Incident date:** 30/07/2018
- **Event:** Struck by plant on construction site
- **Location:** Epping Road at Macquarie Park

Incident Overview

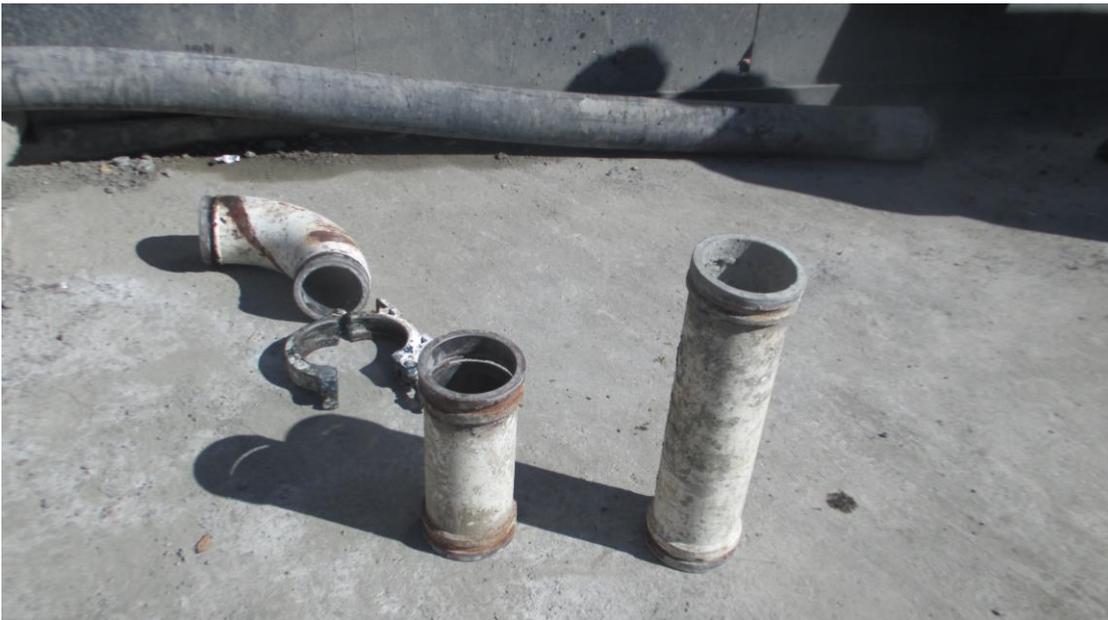
A 36-year-old male worker was agitating concrete being poured into a column. A blockage in the pipework has caused a build-up of pressure. Several pump and delivery line components failed, resulting in the rubber discharge hose striking the worker.

Image of the rubber end (discharge) hose, coupling, elbow and two pump line components.

Due to the cyclic loading of the pulsating pump, the risk of mechanical or structural failure of concrete pumping equipment is increased when compared to other plant, particularly risks associated with:

- fatigue failure of welds
- restraining devices such as pins and circlips becoming dislodged.

- pre-operational inspections are undertaken, including the visual inspection of structural components and other critical components such as fasteners, pins, shafts, welds and locking devices such as pipe clamps are secured with safety pins, and clamp and anchor nuts are tightened adequately

- all lines, pipes, couplings and fittings can withstand the maximum pump pressure (including during blockages) or the pump pressure is adjusted so that it does not exceed pipeline capacity

- all metal pipes and pipeline components are identified and checked for compatibility
- pipes are anchored at intervals specified by the manufacturer, and near joints to prevent bending and casing fatigue failures
