## Serious Incident

- **Incident date:** 7/09/2018
- **Event:** Scaffold Collapse
- **Location:** Bronte

### Incident Overview

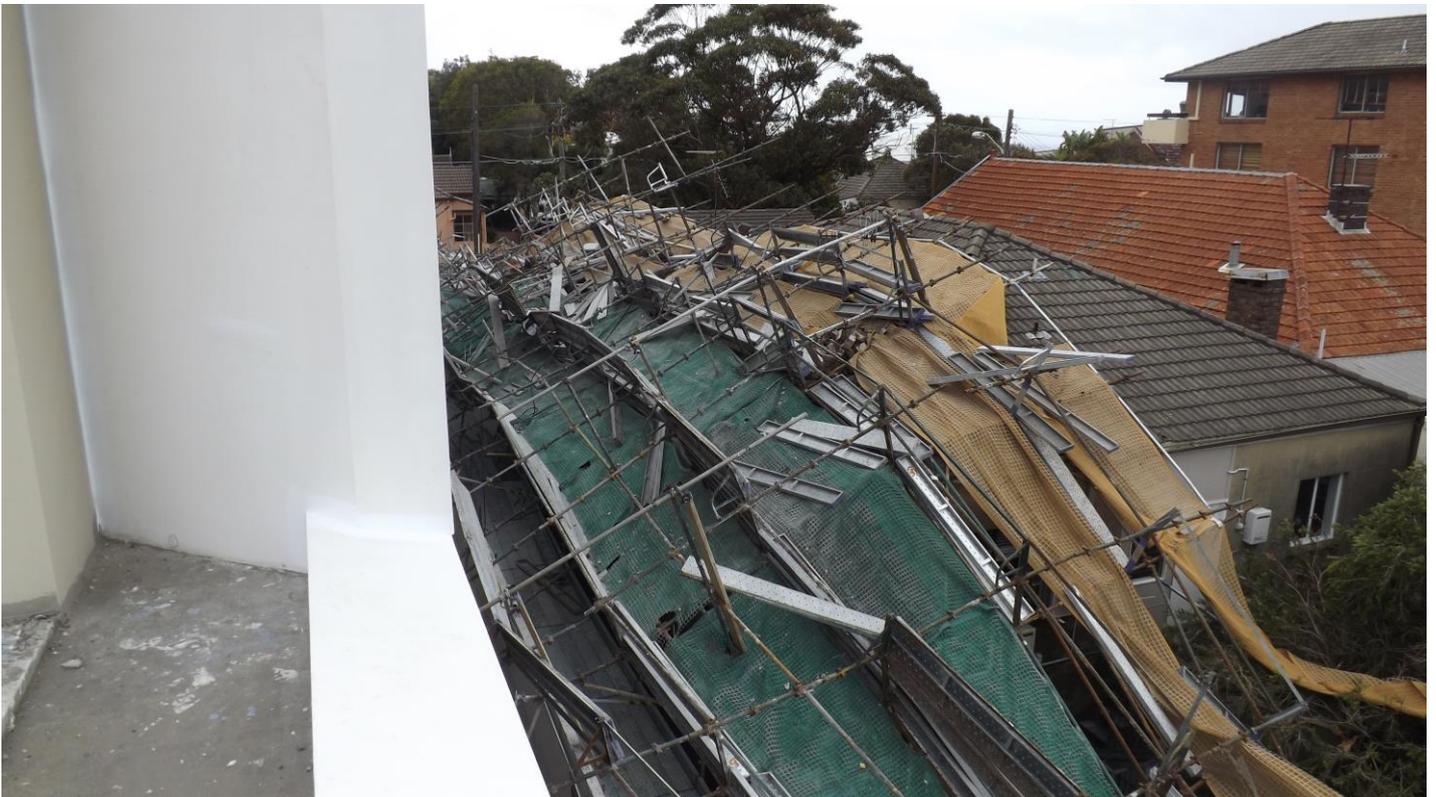
Partially dismantled 4-storey scaffolding on a multi-story residential construction site in Bronte has fallen away from the building and onto the neighbouring unit complex.

View of the 4-storey scaffolding which has collapsed and fallen onto a neighbouring property

- the design of the scaffold installation considers wind load from the scaffold containment sheeting
- provision and maintenance of sufficient ties of adequate strength for the loads, including wind load
- regular inspection of scaffold ties to check they are not modified or altered by unauthorised people (eg finishing trades who may loosen, relocate or remove ties to gain access to walls and openings)
- scaffolds are not left in a state of weakness when installing or dismantling the scaffolds (eg removing returns as they act like ties, or removing ties in preparation for dismantling).
