Serious Injury

- **Incident date:** 6/11/2018
- **Event:** Electric Shock
- **Location:** Guildford

Incident Overview

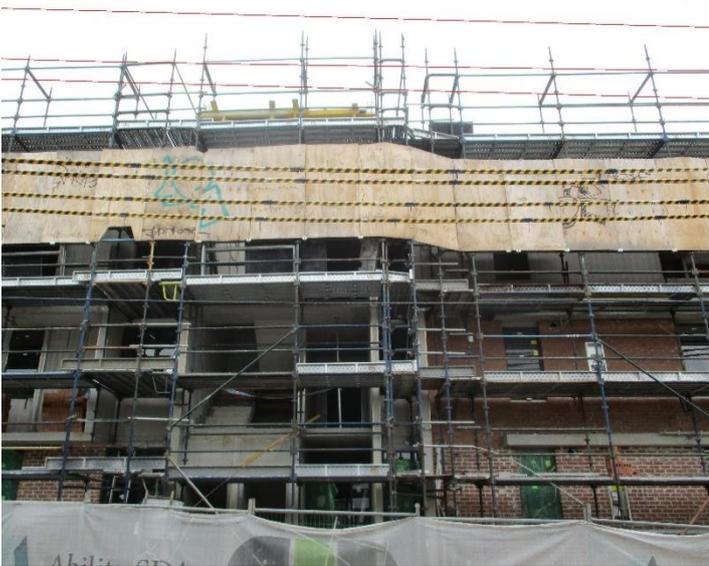
A 36-year-old worker was installing a steel reinforcement bar into a wall cavity on a construction site. While attempting to position the reinforcement bar to insert into the cavity, it extended past the edge of the scaffold and touched high voltage powerlines. The worker received serious injuries.

Image 1: Construction site where work was being done – noting red lines indicate where the power lines were located.

Note the requirements in the AS/NZS 4576 of a 4 metre approach distance for metallic scaffolding used near overhead power lines – where any scaffolding, hand held tools, equipment or materials may come within this 4 metre approach distance, a hazard identification and written risk assessment must be undertaken and measures undertaken to control risks to persons.

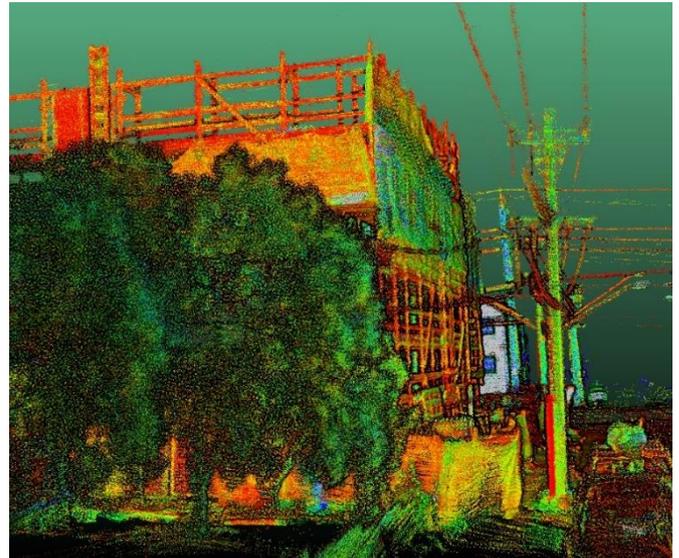
Image 2: Lidar scan, showing construction site and power lines where work was being done.
