## Fatality

- **Incident date:** 17/11/2018
- **Event:** Fall from heights through open penetration/void
- **Location:** Green Valley

## Incident Overview

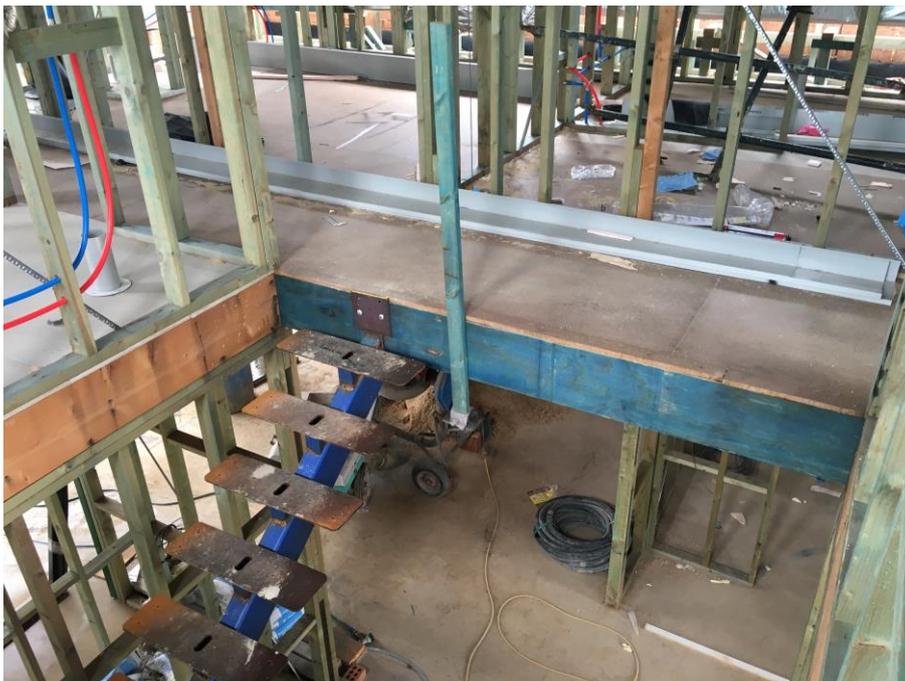
A 29-year-old male air conditioning mechanic fell from the first floor of a residential construction site through a stair void. The worker suffered fatal head and neck injuries.

Image: View of the stair void and access stairs.

- provide edge protection on all open edges where a worker can fall e.g. guardrails comprising top-rail, mid-rail and toe boards.
- cover stair voids with covers designed to withstand likely impact and static loads and fixed to prevent any dislodgement or accidental removal.
- provide workers with safe means of access and egress to work areas.
