Serious Injury

- **Incident date:** 11/09/2018
- **Event:** Fall through penetration
- **Location:** Castle Hill

Incident Overview

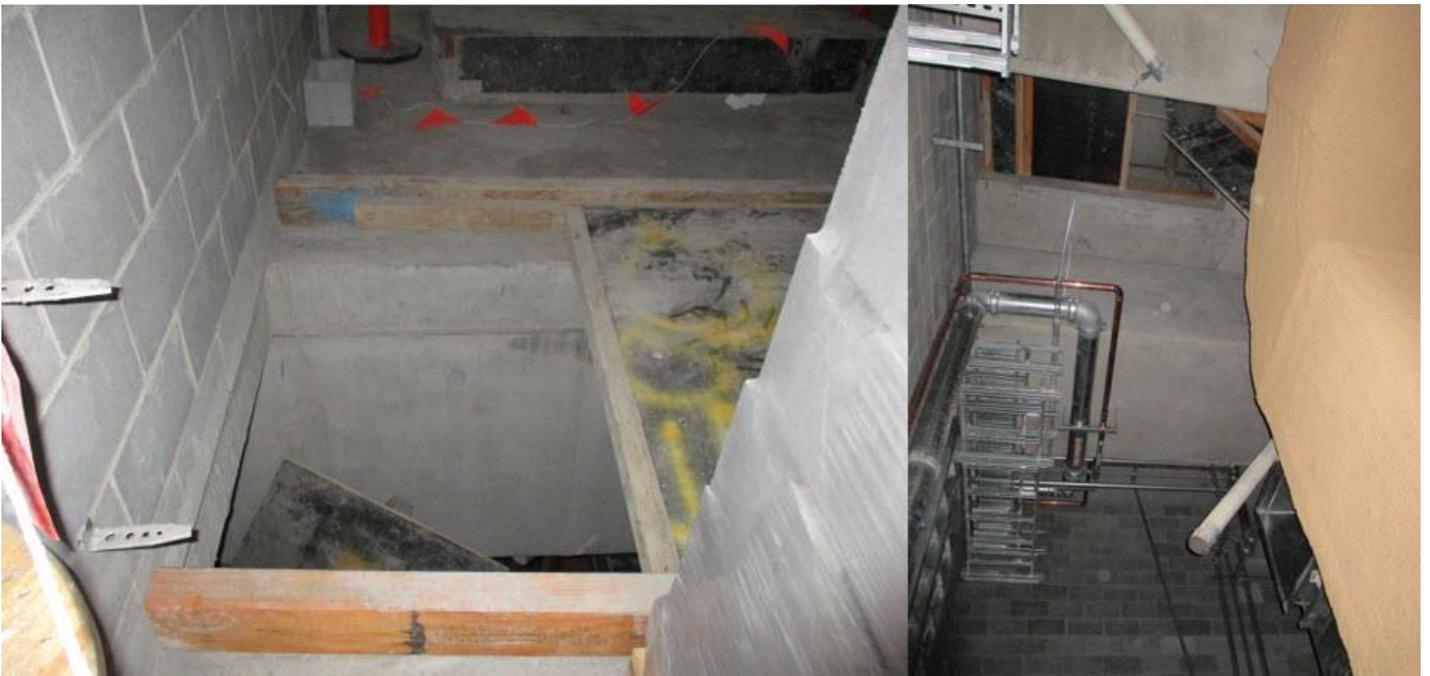
A 28-year-old bricklayer was undertaking work in a plant room of a major tunnel and civil infrastructure works project. He stood on the temporary platform covering a penetration which has shifted under his weight causing him to fall 7.1 metres to the concourse level below. The worker sustained a broken left femur, tibia, fibula and a broken left shoulder.

Image 1 & 2. View of open penetration from the plant room where the worker has fallen through and view from the level below looking up at the opening.

Businesses are reminded to consider reasonably practicable control measures to manage the risk of falling from heights and working near penetrations including;

- Installing barriers, such as guard rails or covers, that are secured and labelled with warning signs in areas where penetrations are present
- Covering and marking, or installing guardrails around penetrations/voids
- Providing workers with safe means of access and egress to work areas
- Conducting a risk assessment prior to working near penetrations
