Serious Injury

- **Incident date:** 24/07/2018
- **Event:** Electrical incident resulting in an arc flash
- **Location:** Bidwill

Incident Overview

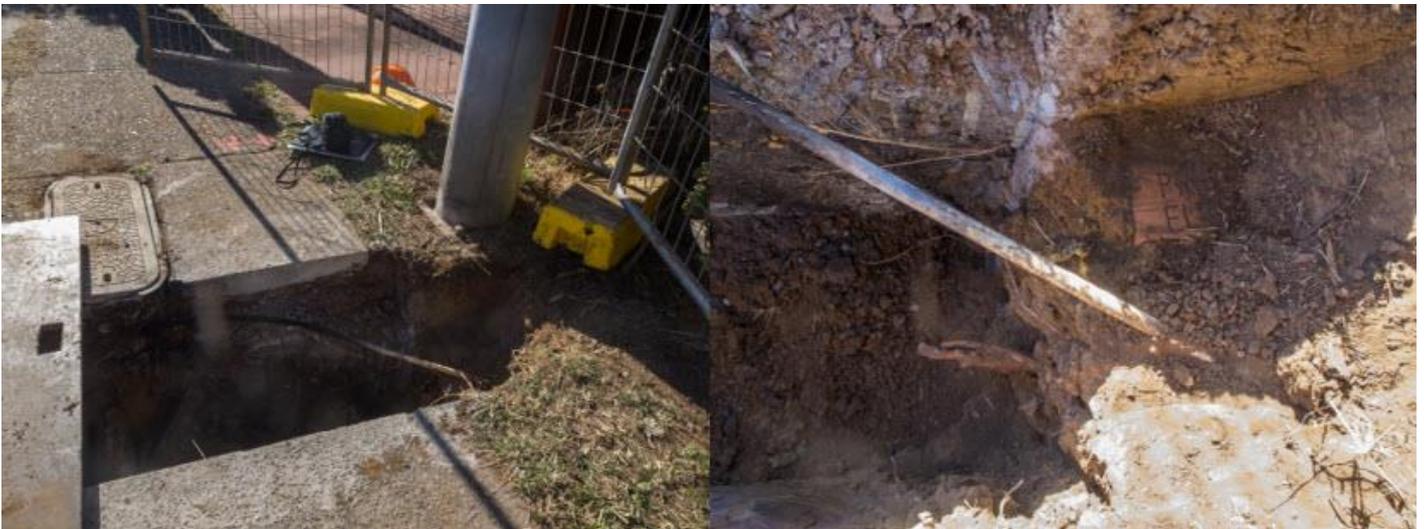
A 31-year old male worker was undertaking excavation works using an electrical hammer drill to remove concrete which covered a shallow trench. The work was being undertaken near low voltage cables and an 11kv high voltage cable, all of which were energised at the time. The worker struck the 11kv cable and an arc flash occurred. He sustained serious burns to his upper body and face.

Photographs: Trench excavation site where works were being undertaken.

Businesses are reminded of their duty to ensure, so far as is reasonably practicable, that no person, plant or thing at the workplace comes within an unsafe distance of an underground electric line.

If it is not reasonably practicable to ensure the safe distance of a person, plant or thing from an underground electric line, you must make sure that:

- a risk assessment is conducted in relation to the proposed work
- the control measures implemented are consistent with the risk assessment and any requirements of the electrical network operator responsible for the electric line.
