# Angle grinder fatality

**1 August 2022**

A 64-year-old male was fatally injured while operating a nine inch angle grinder at a residential construction site in Ermington. The angle grinder was being used to cut a brick pier.

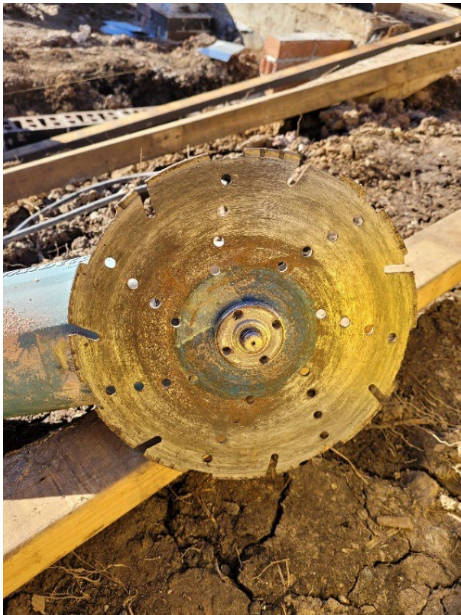
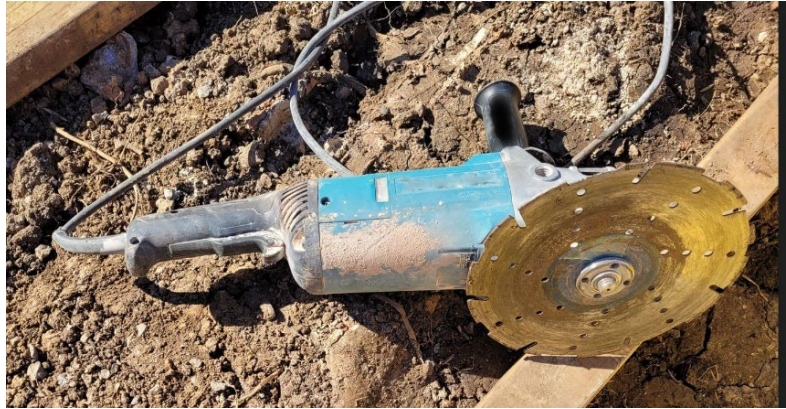
*The angle grinder involved in the incident*

The increased power and size of nine inch (230 mm) angle grinders makes the grinder more difficult to manoeuvre and can cause severe kickback.

- conduct a risk assessment to identify alternative methods and tools prior to selecting a nine inch (230 mm) angle grinder
- carry out a visual inspection of the angle grinder before use, ensure damaged discs are thrown out and not re-used

- use the angle grinder with the correct guard supplied by the manufacturer
- ensure the handle is inserted on the side of the unit that gives the best grip for the work activity

- ensure the angle grinder is maintained and repaired according to the manufacturer's specifications
- ensure the angle grinder has been inspected and tested for electrical faults by a competent person
