# Fatality – fall through roof

9 January 2020

## Incident overview

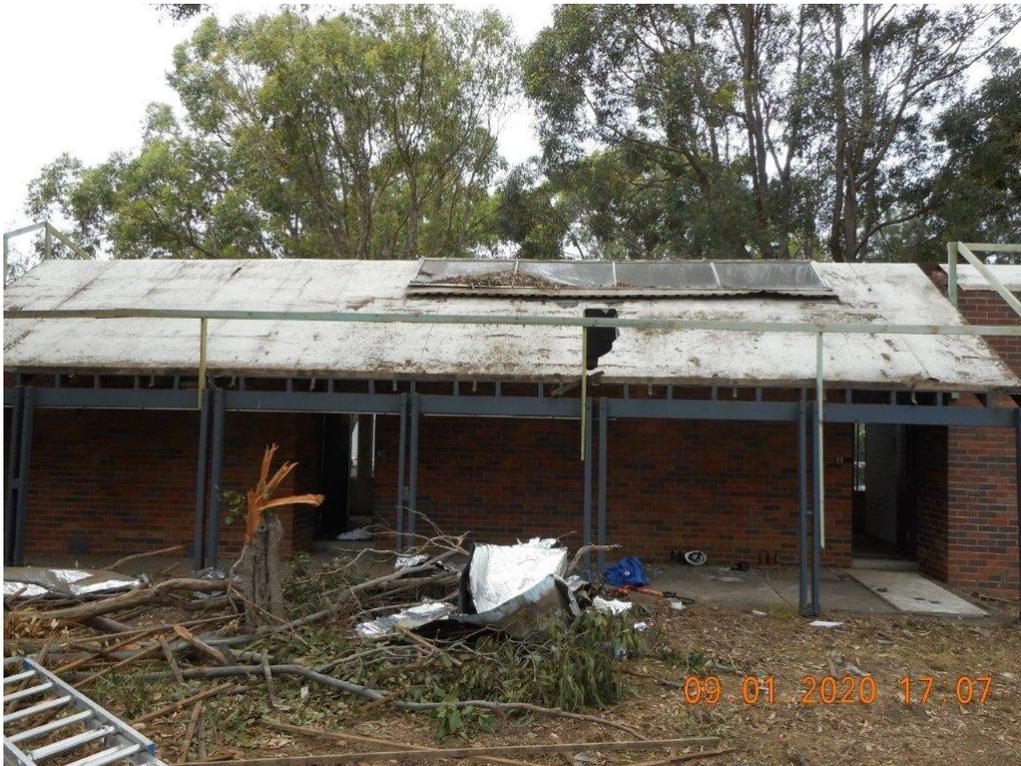
A worker died after falling more than two metres through a fibro roof at Wollongong, while attempting to get onto a ladder to get off the roof.

Before starting work on a roof, you should inspect the condition of sheeting to determine if it can be walked on, such as a skylight, plastic or asbestos cement. Also, inspect the supporting roofing materials and fixings.

- you plan the work to avoid walking on brittle material
- you use an elevated work platform or boom lift, if possible
- you use temporary work platforms, such as crawling boards,
- you use a fall arrest system, such as a harness, with anchor points – train workers how to use it
- install safety mesh.

- it's at a 1:4 ratio
- it's tied off at the top (and/or footed) and extends at least 900mm past the landing
- you don't unclip the lanyard until standing on the ladder
- you review your control measures.
