## Serious Incident

- **Incident date:** 10/09/2018
- **Event:** Fall from height through roof
- **Location:** Newcastle East

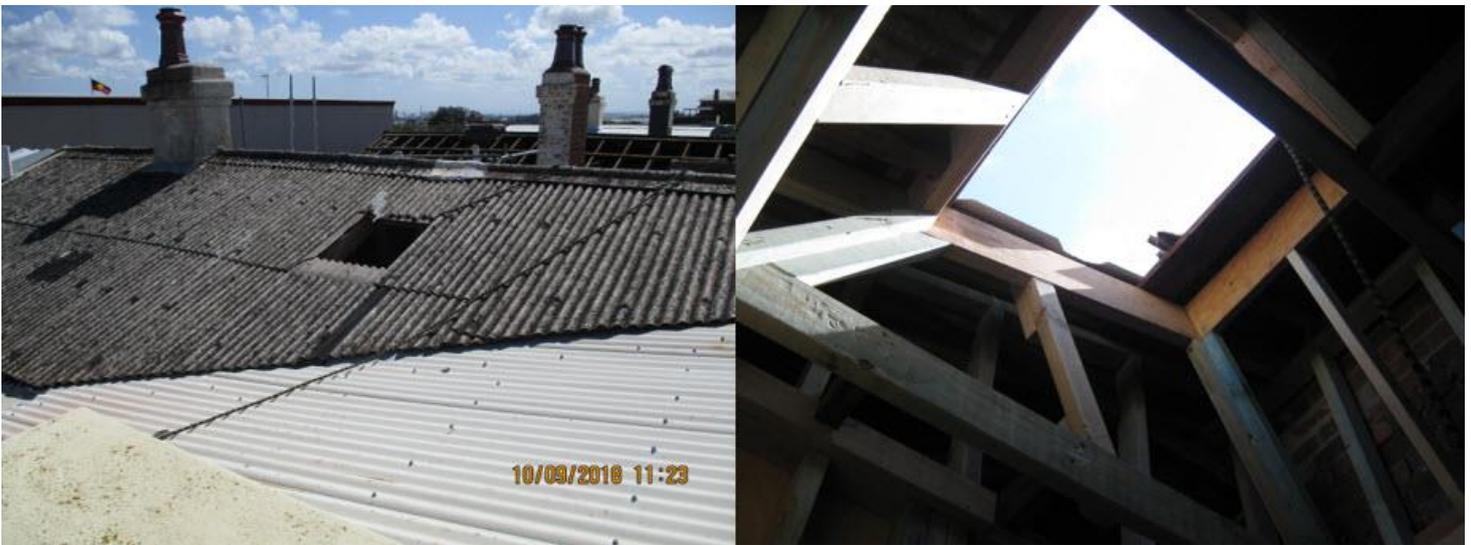
A 26 year-old labourer was on the roof of a home helping remove asbestos cement corrugated roof sheeting when one of the sheets gave way and he fell approximately 4 metres.

The fall-arrest system used did not prevent the worker from hitting the wooden floor below. The worker sustained a suspected broken wrist.

Images of where the asbestos roof sheeting gave way from outside and inside the residence.

Before starting work on an existing roof, carry out an inspection (from below) to determine:

- the presence and condition of non-trafficable sheeting such as asbestos cement sheeting and other brittle roof sheeting such as sky lights or plastic roof sheeting
- for residential properties, the spacing and condition of roof purlins or trusses, including any gaps in purlins
- for commercial properties, the presence and condition of safety mesh.

When determining whether roofs are safe to walk on, consider that product materials may become brittle with age and fixings may become less rigid over time.

Control measures to prevent a person from falling through a non-trafficable roof or skylight include:

- plan to work from below whenever possible
- plan the work to avoid accessing unsafe or non-trafficable areas
- work from an elevated work platform or boom lift to avoid standing on the roof itself
- install temporary work platforms (crawling boards) and roof ladders as appropriate
- install barriers (such as guard rails or covers) that are secured and labelled with warning signs
- install safety mesh when installing the roof sheeting
- install a fall arrest system (harness system) which has adequately-installed anchorage points, along with training and instruction in the use.
- ensure workers using an adjustable length (traveller) fall arrest system are competent and aware that the rope line is to have minimal slack, to protect them in the event they fall through, when walking or working on roofs and are aware of the pendulum effect when using single anchorage points.
