IIR Publication number: IIR20190401

## Fatality

- **Incident date:** 1/04/2019
- **Event:** Scaffold Collapse
- **Location:** Macquarie Park

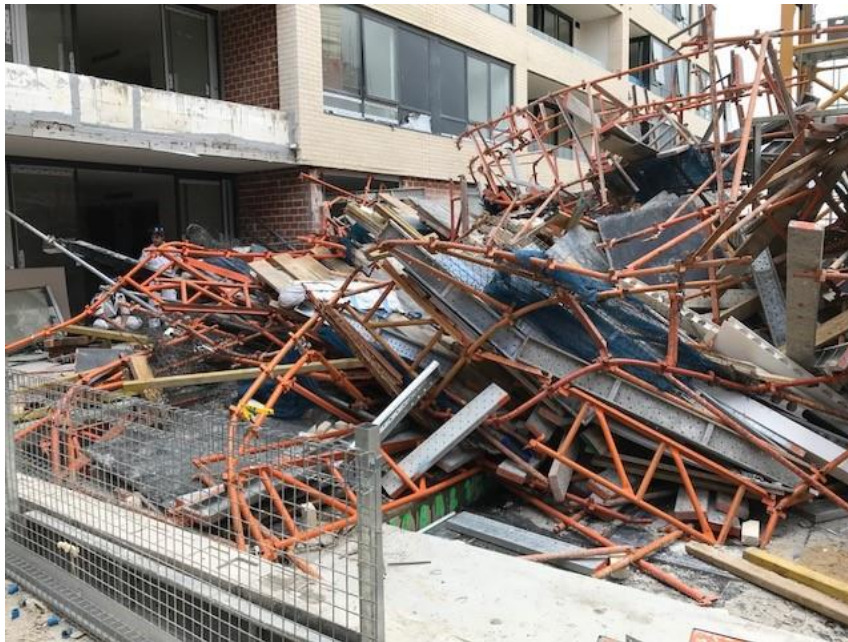
Two formworkers were working on a multi-storey mixed-use construction in Macquarie Park. They were on a concrete slab working beside the base of scaffolding approximately 9 stories high when it collapsed, crushing both workers. One worker was transferred to hospital with critical injuries while the other died at the scene.

Image: Collapsed scaffold on the construction site where work was being done.
