Serious Injury

- **Incident date:** 24/05/2019
- **Event:** Crush injury while moving concrete blocks
- **Location:** LANE COVE WEST

Incident overview

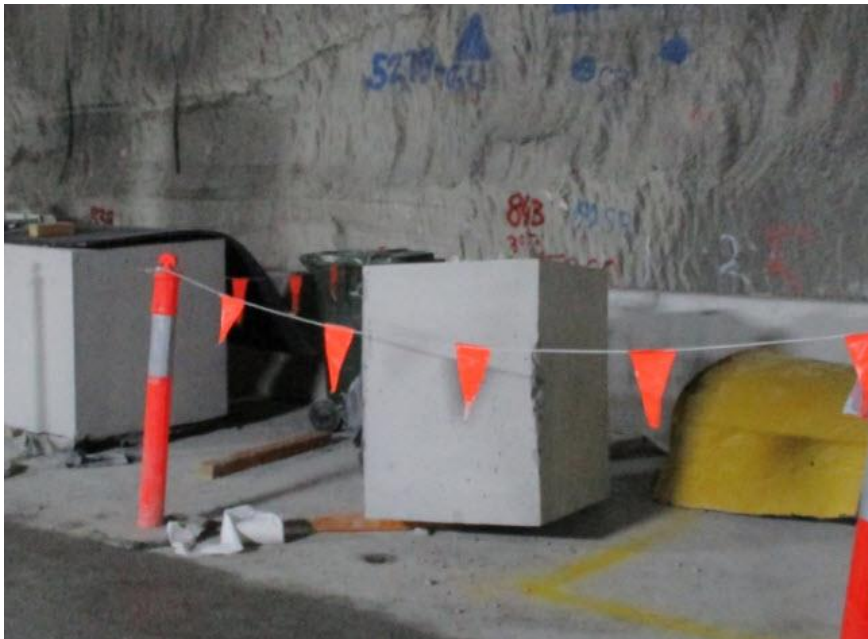
A worker was using an excavator fitted with forklift tines to load large concrete blocks from the ground onto a flatbed truck.

While lifting a concrete block, it moved, pinning another worker (who was helping with the lift) against the truck. The worker received a suspected fractured pelvis.

Photograph: The concrete block that was being moved at the time of the incident.

Businesses must consider reasonably practicable control measures to manage the risks when moving heavy loads. These include:

- Ensure mobile plant attachments are fit for purpose, appropriate for the item of plant, and properly fitted and connected prior to use
- Ensure all loads are lifted, carried and stored in a manner that ensures the stability of the mobile plant, the security of the load and any attachments
- Always consider the weight, size and composition of the load when making decisions about what equipment and safe method to use before doing any lift
- Travel with the load lowered to allow the operator to see and maintain stability of the load
- Avoid lifting any unsecured loads
- Never exceed the rated capacity of the lifting equipment
- Never sling a load from the tines
- Ensure all operators of any lifting equipment are appropriately trained and correctly licenced.
