Incident Information Release

Fall from scaffold on slipway

12 November 2021

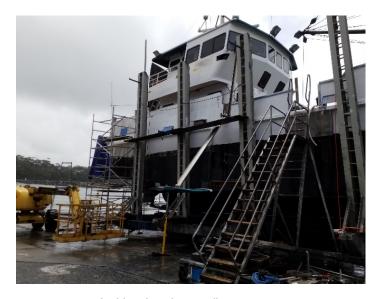
A 67-year-old worker performing repairs and maintenance to a vessel has fallen from bracket scaffolding on a slipway in Ulladulla. The worker removed a timber scaffolding plank before falling approximately three to four metres to the concrete ground below. As a result of the incident the worker sustained foot, leg, hip and spinal fractures.

Incident location on slipway

Employers must consult with other duty holders and manage the risk of falls at the workplace by working from the ground or solid construction. If this is not possible, consider using fall prevention devices, a work positioning system or fall arrest system.

- scaffolding includes edge protection if:
 - a person could fall more than two metres, or
 - if a fall of less than two metres is reasonably likely to cause injury
- scaffolding where a person could fall more than four metres must be erected by a licenced scaffolder and have a valid handover certificate
- work positioning systems include industrial rope access or a restraint system that stops a worker reaching a position where they could fall
- falls arrest systems includes catch nets and harness-based fall arrest systems such systems should only be used by workers with suitable training and a rescue plan to retrieve a fallen worker is required
- other measures to control the risk of falls are in place, including having safe systems of work (Safe Work Method Statements) and adequate training/supervision of workers.
