Serious Incident

- **Incident date:** 6/07/2018
- **Event:** Falling object from construction site
- **Location:** Princes Highway at Rockdale

Incident Overview

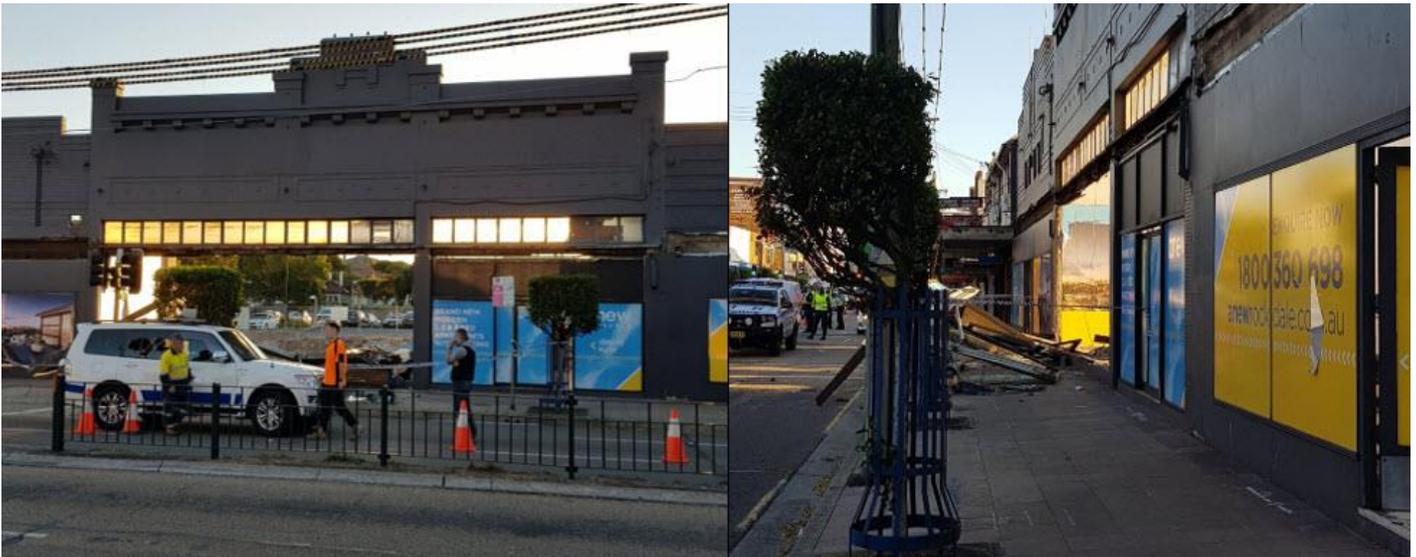
During the demolition of an existing commercial premises, parts of the front façade fell onto the pedestrian footpath, scattering debris onto the footpath and the Princes Highway. The incident occurred during strong winds. As a result, two northbound lanes of the highway were closed. There were no reported injuries.

Front and side view of the building façade with a view of the façade collapse onto the footpath.

The site is located on Princes Highway at Rockdale. The site is currently undergoing demolition and is under the control of a principal contractor. A sub-contractor had also been engaged to carry out demolition works on the site. At the time of the incident, the front façade and partial return / buttress walls were the only building elements yet to be demolished. The front façade consisted of brickwork, and glass windows and doors.

Businesses are required to implement reasonably practicable measures to eliminate or minimise the risks associated with unplanned structural collapse or falling debris by ensuring:

- the demolition method and sequencing is planned in consultation with the building/structure designers, or if it is not reasonably practicable to do so, in consultation with appropriately competent persons e.g. structural engineers.

- the building or structure to be demolished and all its components are maintained in a safe and structurally stable condition at all times until completion of the project. Temporary braces, propping, shoring or guys may need to be added to ensure that stability of the structure is maintained.

- external factors that may impact on the structural integrity of the building or structure are considered and the associated risks are managed e.g. vibrations from demolition activities, wind, water pooling or egress around footings or supports.

- adequate protection to members of the public are provided and maintained by installing, for example, hoarding, overhead protective structures, heavy duty scaffolding and/or or containment screening; or by implementing road closures and/or specified exclusion zones.

- measures installed to provide public protection are designed and constructed to withstand the applicable loads (consultation with an appropriately competent person may be required).

- measures installed to provide public protection are in place prior to commencing associated demolition works.
- all control measures are monitored by a competent person to assess the on-going suitability of the demolition method and sequencing and to identify signs of structural weakening e.g. movement or cracking.
