**Incident Information Release**

# SAFEWORK NSW

# Roof collapse

#### 9 May 2022

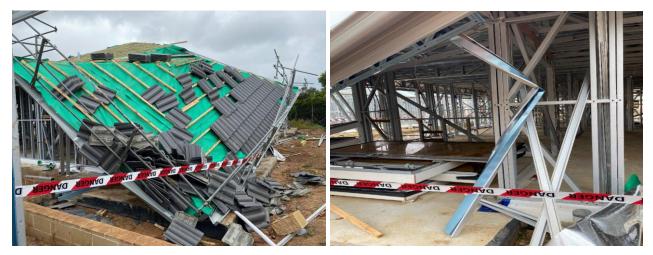
A 30-year-old worker sustained injuries when the temporary support post for the roof he was tiling failed, causing the roof to collapse. At the time, tiles had been stacked on the unsupported eaves in preparation to be installed.

The collapsed roof and the temporary support that gave way.

- consult with suitably qualified and competent persons regarding engineering and structural requirements during construction
- follow all engineering and construction requirements as per the approved construction plans, including meeting hold points and inspection requirements
- ensure structural supports are correctly sized and have the load bearing capacity required
- ensure temporary structural supports are correctly located and fixed in position

- ensure heavy materials are not placed on unsupported roof areas
- implement safe work areas to reduce the risk to workers working beneath structures from being injured from falling objects or crush injuries in the event of a structural collapse
- communicate any safety concerns with the designer or engineer and do not continue work until the issue is resolved
- ensure a <u>SafeWork Method Statement (SWMS</u>) is developed, and followed, for high-risk work
- ensure all workers have the required licences and qualifications
- ensure all workers complete a site induction and are provided with all relevant safety information
- ensure all workers are wearing the correct PPE
- prepare an emergency plan for the site.
