Serious Incident

- **Incident date:** 19/04/2019
- **Event:** Painter falls from heights working on a ladder
- **Location:** WILLOUGHBY

Incident overview

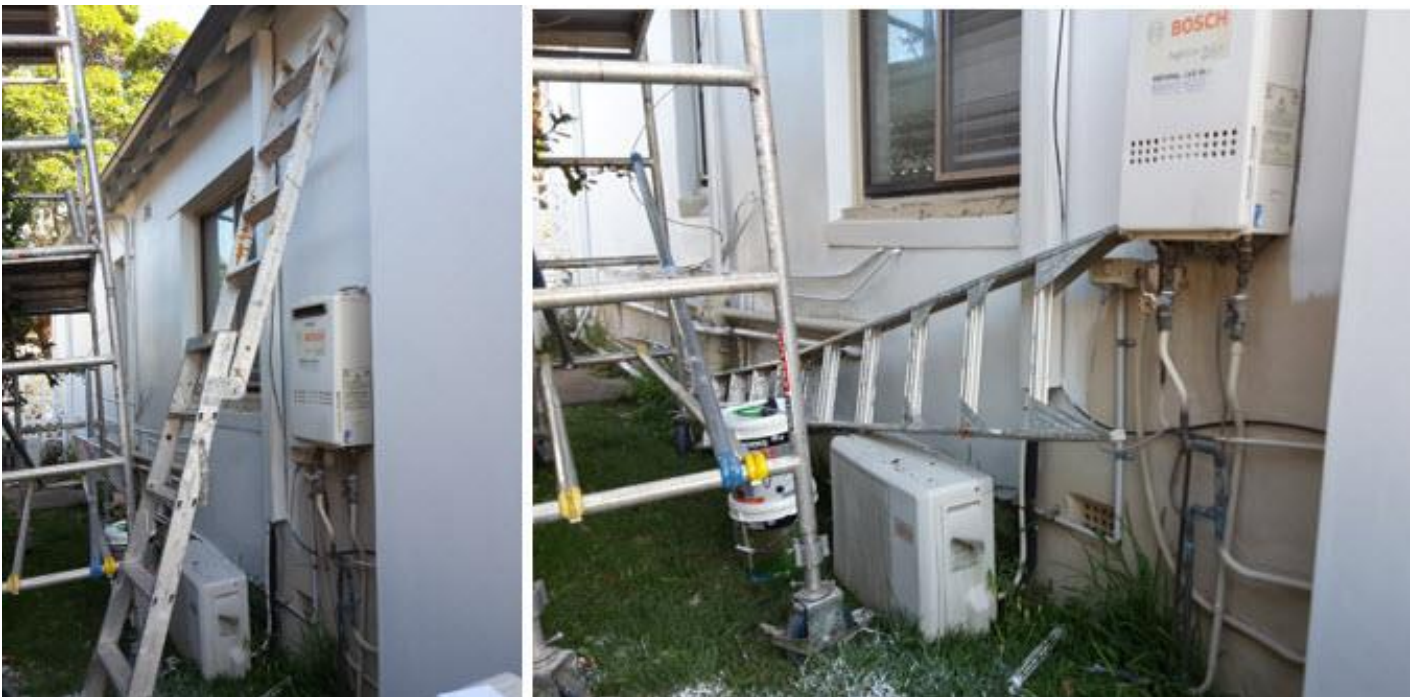
A painter working from the side of a house fell from a ladder and broke his ankle. He was taken to hospital for treatment.

Images show the approximate ladder position before and after the fall.

Businesses are reminded to consider reasonably practicable control measures to manage the risk of falls from heights, particularly when working on ladders.

- Straight/extension ladders should be angled at a ratio of 1:4. That is, position the base of the ladder 1 metre away from the structure for every 4 metres of height.
