Incident Information Release

Fall from scaffold

25 July 2022

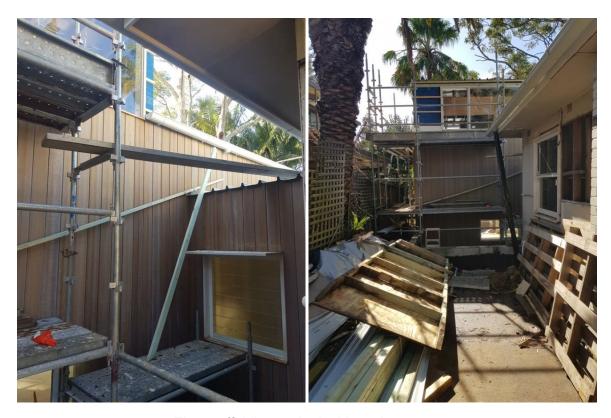
A 26-year-old apprentice sustained serious injuries when he fell from incomplete scaffolding used to access the roof of a two-storey house under construction in Avalon Beach.

The scaffolding at the incident site.

When working with scaffolding, businesses must ensure:

- any erection, alteration or dismantling work on scaffolding with a risk of fall of greater than 4
 metres is performed by a person with the relevant <u>High Risk Work Licence (HRWL)</u>

- scaffolding is only constructed on solid foundations and is adequately tied to the supporting structure
- handrails, mid-rails, and planks are securely installed

- workers are provided with a safe way to access and exit the work area
- safe access and egress onto stairs and between deck levels
- workers do not climb on top of rails or on the outside of the structure

- workers, supplies and equipment to be used on the scaffolding are under the duty rating (weight limit)
- voids and penetrations are covered and appropriately marked

- mesh and kickboards are installed to scaffolding to prevent debris falling onto neighbouring properties or workers below the work area
- scaffolding is inspected by a qualified person at least every 30 days and tagged with the inspection date

- workers complete a visual check of the scaffold daily before use and report any defects or issues for rectification
- a <u>Safe Work Method Statement (SWMS)</u> for working at heights is prepared for any height with a risk of a fall of over 2 metres

- all workers complete a site-specific induction and are trained in the appropriate SWMS for working at heights including working on scaffold.
