Bogged farm machinery fatality

18 June 2022

A 33-year-old farmer sustained fatal head injuries during the extraction of a bogged bulldozer at his neighbour's farm in Regional NSW. He had been assisting his neighbour with the extraction when one of the two D-Shackles connecting the recovery strap failed and was propelled through the glass door of the bulldozer.

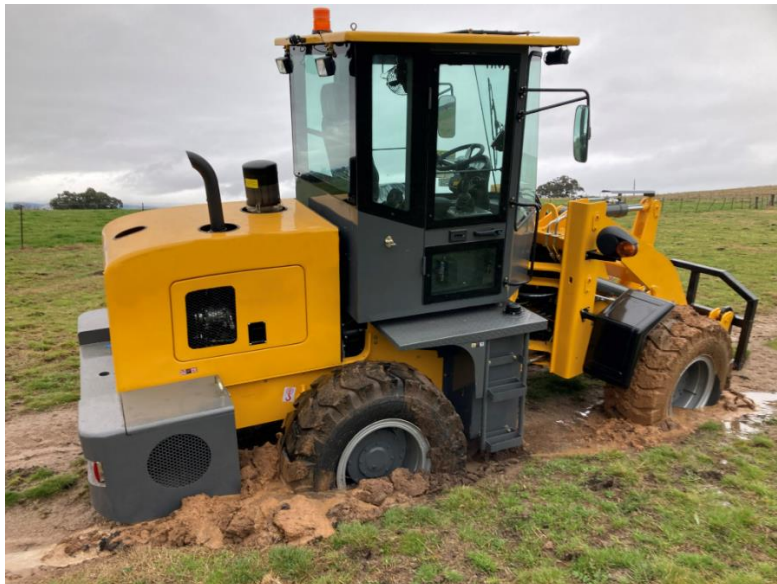
An example of bogged farm machinery.
