Fatality

- **Incident date:** 23/08/2018
- **Event:** Fall from height through plastic roof sheeting
- **Location:** Tomago in Northern NSW

Incident Overview

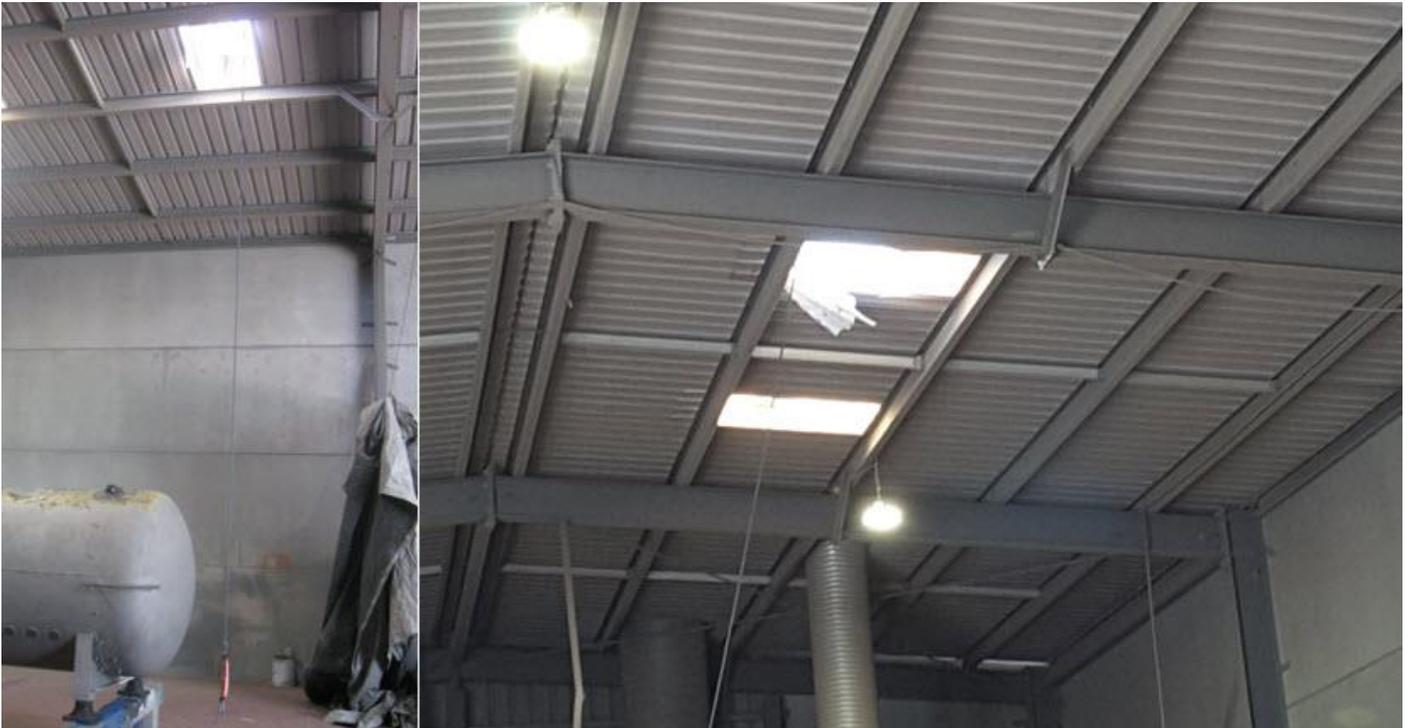
A 19-year-old first year apprentice electrician was on the roof of a single storey commercial building, assisting with the installation of solar panels. The worker stepped on a plastic roof sheet and fell approximately 7 metres. The rope line had excessive slack between the worker and the anchorage point. The excessive slack in the rope line allowed the worker to fall the 7 metres to the concrete slab below.

View of the broken roof sheeting from within the building.

Control measures to prevent a person from falling through a non-trafficable roof or skylight include:

- plan the work to avoid accessing unsafe areas
- work from a solid construction to avoid standing on the roof itself
- install temporary work platforms (crawling boards) and roof ladders as appropriate
- install barriers, such as guard rails or covers, that are secured and labelled with warning signs
- install safety mesh when installing the roof sheeting
- install a fall arrest system (harness system) which has adequately-installed anchorage points, along with training and instruction in the use.
- ensure workers using an adjustable length fall arrest system are competent and aware that the system is intended to provide protection against falling through the roof, not just falls off the edge, and therefore they need to adjust the length to limit slack as they move.
