Serious Incident

- **Incident date:** 29/10/2018
- **Event:** Prefabricated concrete panel fall on construction site
- **Location:** Bexley

Incident Overview

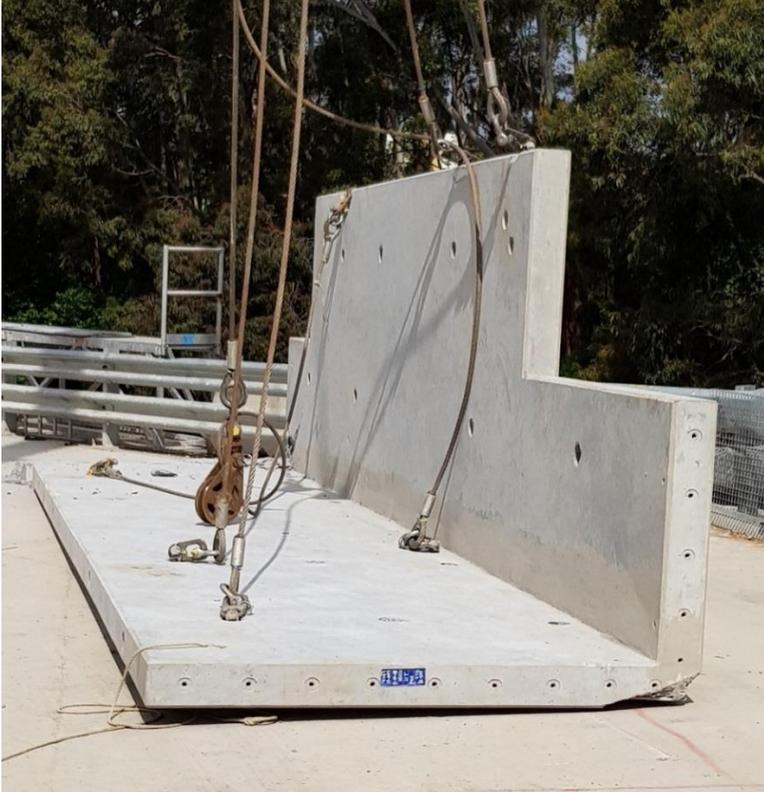
A 21 tonne, right angle shaped, prefabricated concrete panel was being lifted by a tower crane and a mobile crane in a dual lift. The panel was approximately 9.3 metres long by 2.5 metres wide.

As the panel was being lifted into position the lifting equipment and/or lifting point failed and the panel suddenly dropped. The reason for the failure is not yet known.

A hoist rope was damaged in the incident and the cranes were subjected to shock loading. Debris from the incident landed in a public area next to the site. There were no reported injuries.

Image: A prefabricated concrete panel that dropped during installation.

The force applied to a crane and lifting equipment can change a lot during a lift. An erection plan is needed to make sure the crane, lifting equipment and concrete element can withstand the applied loads.

The erection plan should be developed in consultation with relevant contractors, including the concrete element prefabricator. It should include drawings that have details on the types and locations of all lifting / bracing / fixing inserts and any component reinforcing.

Documents about the erection plan should be available on site. They should specify the erection sequence and orientation, the correct lifting points, clutches and the rigging details/configuration.

Lifting inserts and clutches must be compatible with each other - seek advice from the item manufacturer if you are unsure. Cranes with sufficient size to use the specified rigging and sling angles, and capacity to handle the calculated load share, must be used.

Before lifting anything, make sure the concrete has reached the required strength and the lift can be done as described in the erection plan. Do not deviate from the erection plan, without agreement of the erection designer.
